CONSULTING ARBORISTS — URBAN FORESTRY SPECIALISTS

**McKenzie Park Tree Assessment Follow-Up
City of Panama City, FL
March 18, 2021**

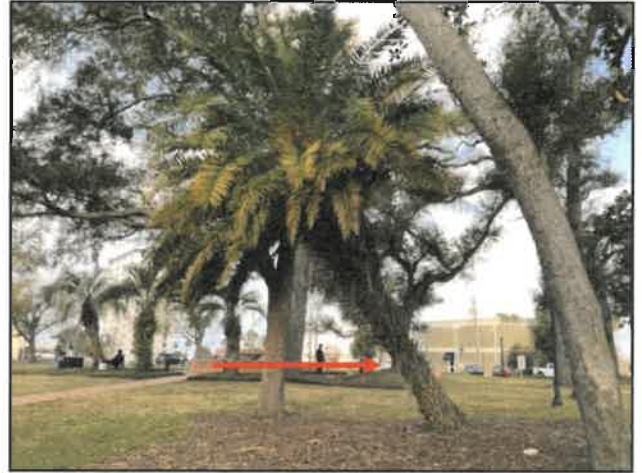
Tree #1606: This is a Date Palm (*Phoenix dactylifera*) with a trunk diameter of 20 inches, a trunk length of 25 feet, and a crown spread of 15 feet. The trunk is leaning significantly. This is a non-native species that is growing outside of its recommended range. Although the tree poses minimal risk to park visitors, I would think that the city would want to remove a tree that is in such poor structural condition, particularly when they plan to undertake a comprehensive renovation of the park. They could utilize this space to plant a much more desirable specimen.

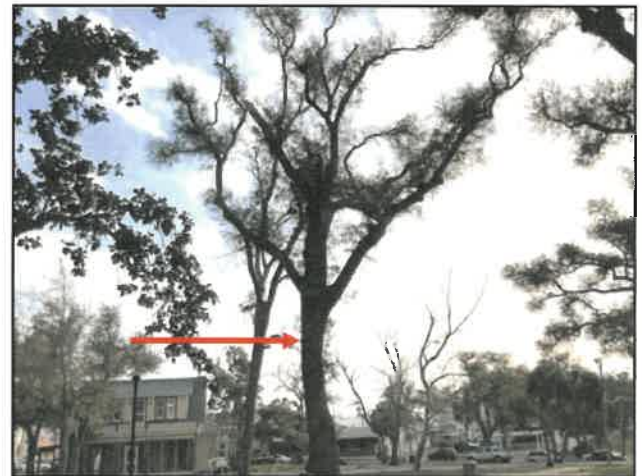
Tree #1588: This is a Live Oak (*Quercus virginiana*) with a trunk diameter of 38 inches, a height of 65 feet, and a crown spread of 50 feet. The trunk is hollow up to a height of at least six feet. Therefore, the ability of the trunk to support the substantial upper portion of the tree is compromised. In addition, park renovation plans call for refurbishment of a walkway that lies about 10-12 feet from the trunk of this tree. This is well within the tree's Critical Root Zone (CRZ). Site disturbance to renovate the sidewalk is likely to compromise the tree's root system to at least some extent. Even without the renovations, the long term longevity of this tree is questionable.

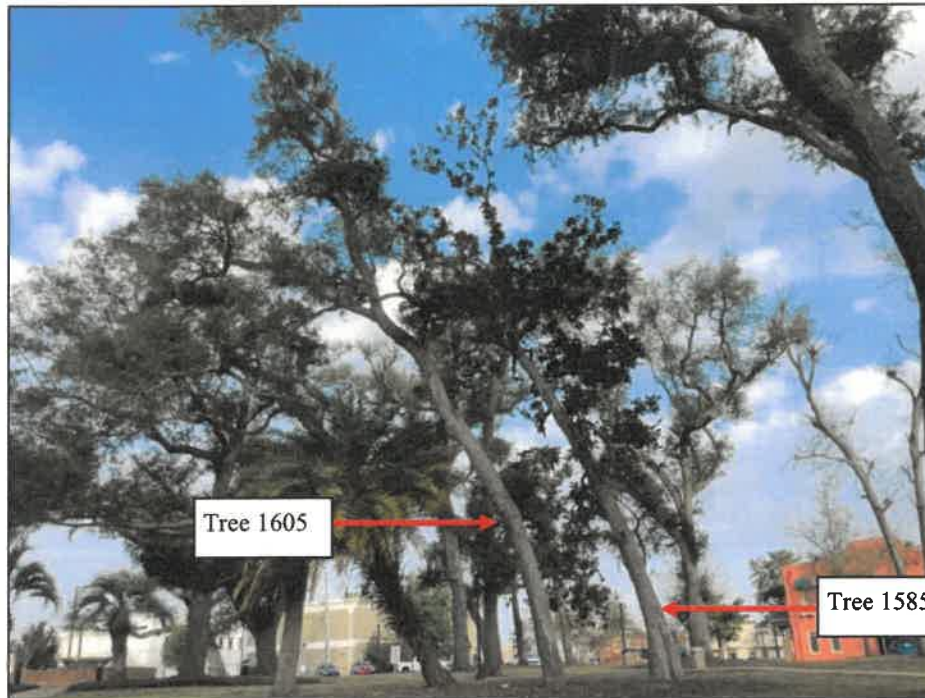
Tree #1585: This is a Southern Magnolia (*Magnolia grandiflora*) with a trunk diameter of 21 inches, a trunk length of 60 feet and a crown spread of about 30 feet.

Tree #1605: This is a Live Oak tree with a trunk diameter of 17 inches, a trunk length of 55 feet, and a crown spread of about 25 feet.

Both trees are leaning significantly, have narrow limb structure, and are exhibiting foliage dieback beginning at the tops of their crowns. This indicates that the root systems are no longer providing adequate water and nutrients to reach throughout the entire trees. The prognosis for their long term longevity is not good and they do present some risk to park visitors. Once again, this space could be better utilized by more desirable specimen trees. A photo of these two trees is located on the following page.

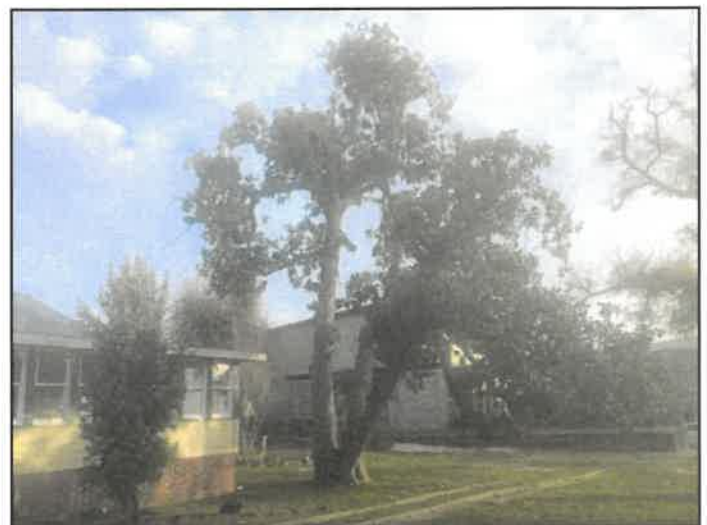
Tree #3161: This is a Southern Magnolia tree with a trunk diameter of 51 inches, a height of 45 feet, and a crown spread of approximately 40 feet. The trunk forks into three vertical stems at a height of about 2.5 feet. This is a distinctive specimen tree residing behind the historic McKenzie House. City staff have expressed concern about the tree's condition.

The tree is currently exhibiting some crown dieback and a number of chlorotic leaves. Foliage at the top of the tree, however, appears to be in good shape. Even evergreen trees like the Magnolia shed their older leaves on a seasonal basis as new leaves grow in to take their place. Weather variations from one year to the next can make this process more apparent.

Two cables support a limb on the southeast side of the tree. The cables appear to be well adjusted and performing their intended function. The limb contains some decay, but that appears to have been present for some time now. The junction of the three vertical limbs at the base of the tree appears to be sound. Overall, no structural problems appear to exist.

I recommend waiting for another one to two months to see if this pattern comes to fruition or if we need to revisit the issue. Dead branches can be removed but they don't currently pose a significant risk.

This tree could benefit from the addition of nutrients. In addition, the application of a Tree Growth Regulator (TGR) would transfer some carbohydrates from the above ground portion of the tree to the root system, improving the tree's health over time. This is a service that I am set up to perform and I can discuss with city officials upon request.
