CONSULTING ARBORISTS — URBAN FORESTRY SPECIALISTS

**McKenzie Park Tree Assessment Follow-Up
City of Panama City, FL
March 18, 2021**

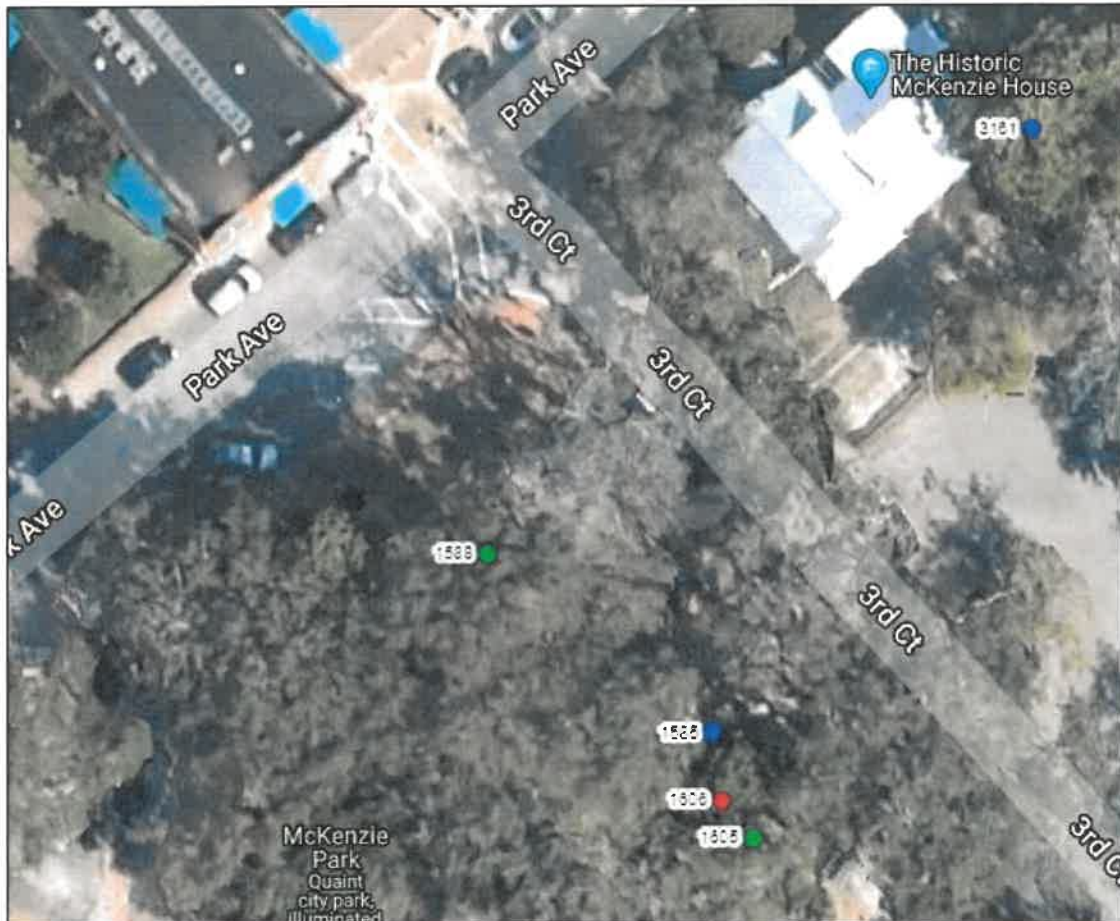
Panama City officials have requested additional information regarding four trees that were recommended for removal in the report that I provided in February, evidently in response to public comment. In addition, they also requested an assessment of a large specimen Magnolia tree (*Magnolia grandiflora*) that resides directly behind the McKenzie House. The locations of these trees are indicated on the following map.
